# MONUMENT RECORD

Corner ID: **BeBI\_U21**

Sections 25, 26, 35, & 36- T10N-R02W, 2nd P.M.  
Bean Blossom Township, Monroe County, Indiana

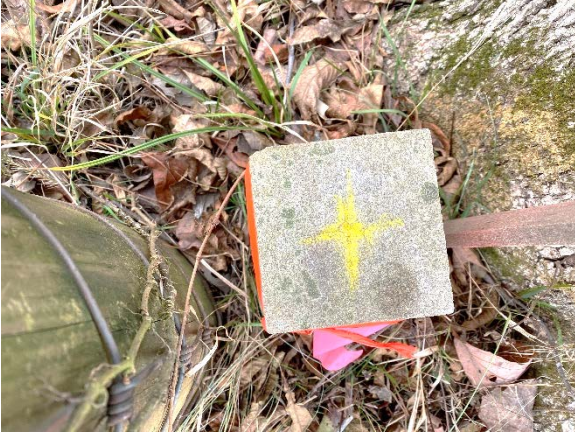
Photo Orientation & Description: BeBI\_U21 from above

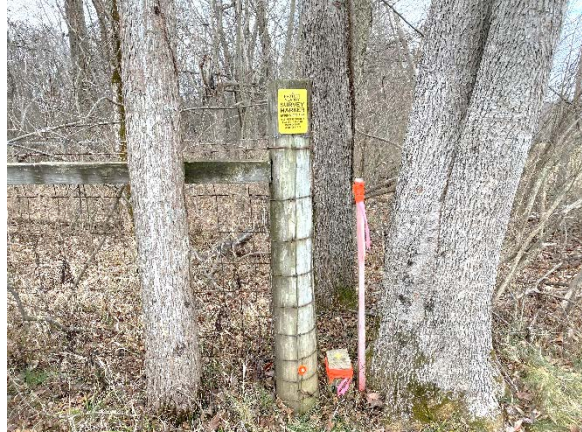
Photo Orientation & Description: Looking west at BeBI\_U21

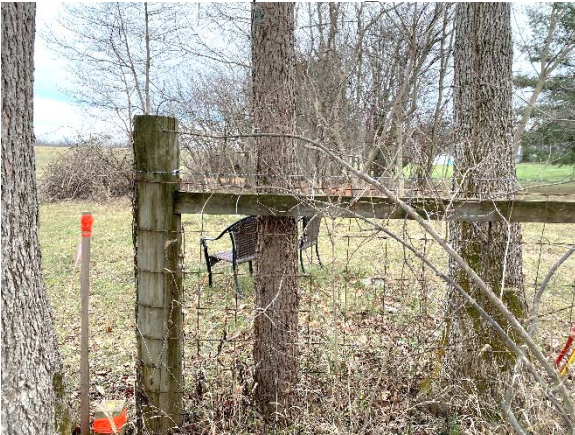
Photo Orientation & Description: Looking east at BeBI\_U21

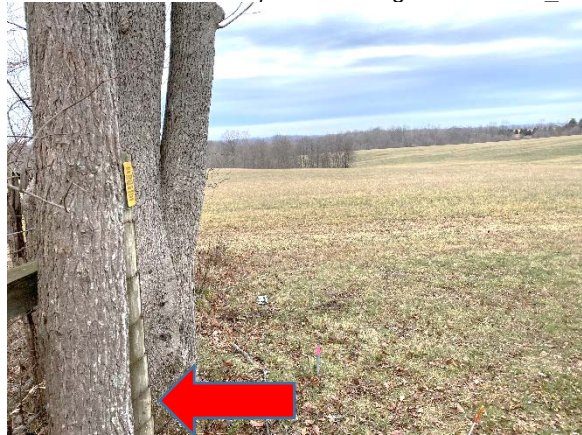
Photo Orientation & Description: Looking north at BeBI\_U21

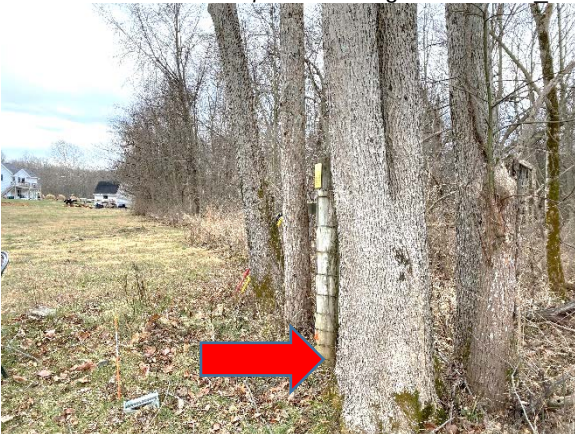
Photo Orientation & Description: Looking south at BeBI\_U21
